## Industrial Plants

### **Sancor Plant**

**Client** Sancor Cooperativas Unidas

Location Porteña, Córdoba province, Argentina

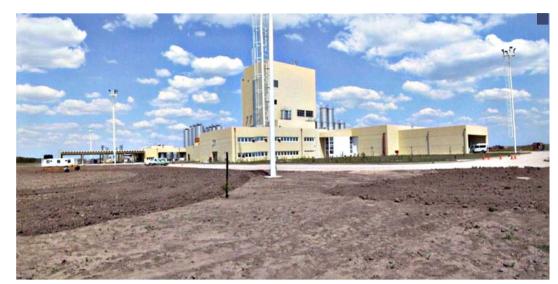
Skanska LA has performed the construction of a cheese by-products elaborating plant.

The plant is located at the km 37 of the provincial route  $N^{\circ}$  1, 8 km to the north of the city Porteña. The lot that occupies is 25 hectares large and the constructed area is 12.700 m<sup>2</sup>.

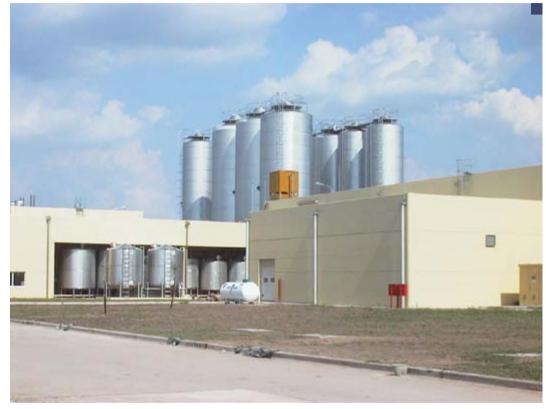
Masonry: these works included the construction and / or installation of: Block walls of CCA (8.500 m²), insulations, covers, hanging plastered ceilings, subfloors, ceramic floors, projected plasters (17.000 m²), ceramic lining, latex paint (12.300 m²), epoxy paint (22.200 m²), exterior paint (11.000 m²), acrylic paint over geotextile membrane (10.000 m²), PVC and metallic carpentry, covers waterproofing with geotextile membrane (10.000 m²).
